DEMONSTRATING BIM IMPLEMENTATION ON RENOVATION PROJECTS

Agnieszka Łukaszewska
Head of R&D
FASADA

Sustainable Places

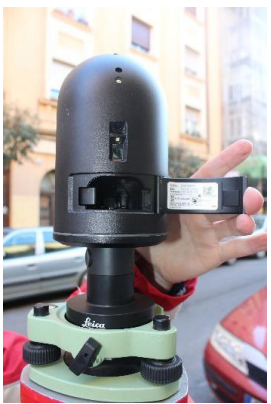
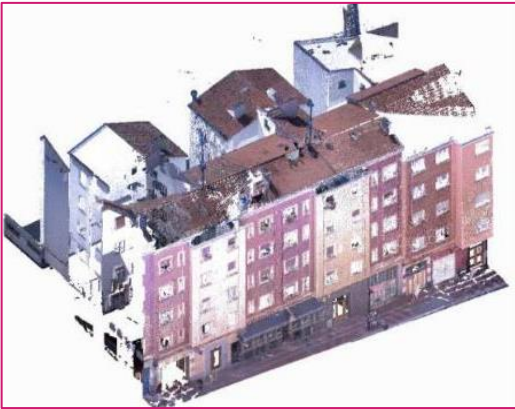
**3D SCANNING &
3D Scan-to-BIM
(3DASH tool)**

Performed work: As-built BIM Regarding models have been completed for both buildings. BIM to BEM Model has been Completed in ALD26. Several BIM-SPEED tools have been already tested: **BACN2BIM**, **3DAHS tool (3D Scan-to-BIM)**, **BIM-BEM (Cartif procedure)**, **ECOf tool**, **MEREEN weather service**, **BIM Maturity Tool**, **Acoustic tool / simulation**, **Thermal texturing of BIM** and **BIM-SPEED BIM Library** have been used. Augmented Reality tool is being tested by ARCHITECTURAL SPIES.

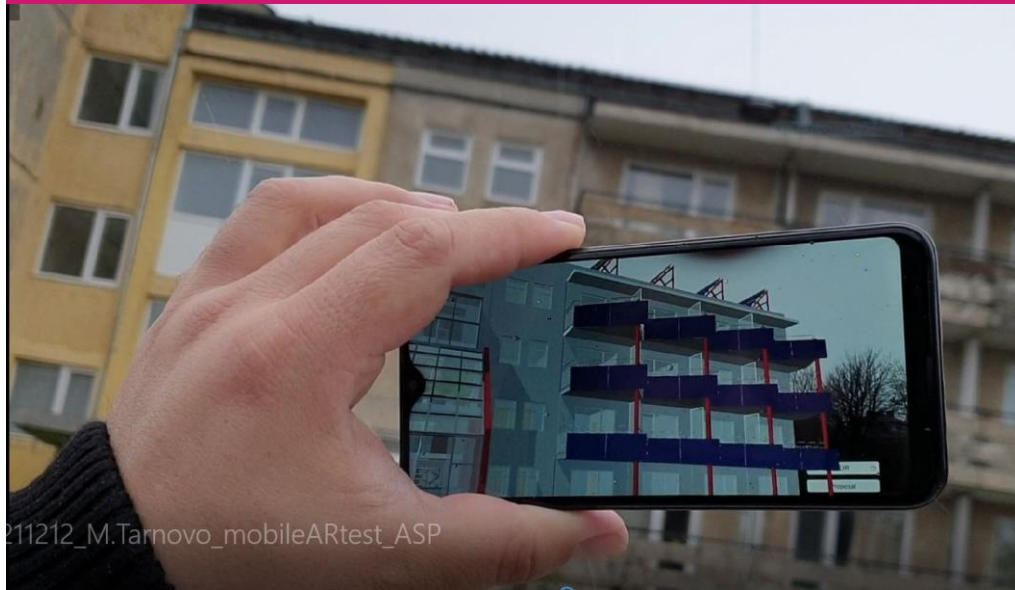
Mobile Augmented reality tool

Performed work: As-built BIM model was performed, based on Energy simulation and Multicriteria decision making tool best renovation scenario was selected. Mobile augmented reality tool allows to see how the building will look like after renovation or the thermal models of the buildings

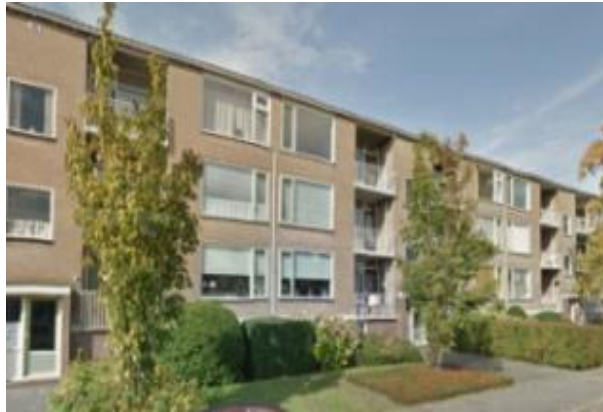
Characteristic: The complex consists of a three-storey, multi-family building blocks, built in 1969. The buildings are located in Warmond in the Netherlands. The buildings are privately owned and at the moment, all dwellings have tenants. The current energy label is D.

DEMONSTRATION
SITE

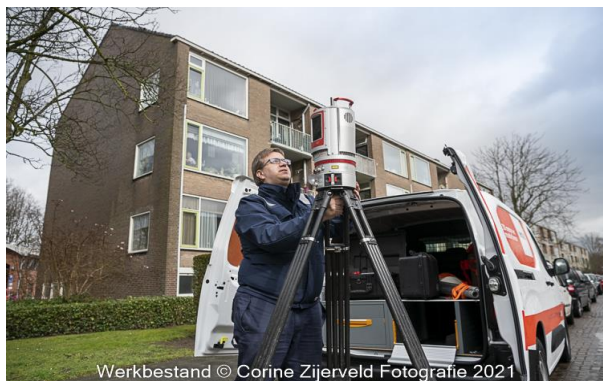
Performed work: Based on the point cloud deviation analysis was performed and the as-built BIM model was developed. The measurement survey performed in the Warmond demo site allowed to collect all relevant data for acoustic comfort evaluation before renovation and for the calibration of BIM based acoustic comfort models. Installation of the tool „comfort eye” (developed by project partner UNIVPM) for monitoring of indoor environmental quality in 5 flats.

3D
SCANNING
